INVESTIGATION INTO THE EFFECTS OF VHF AND UHF BAND RADIATION ON HEWLETT-PACKARD (HP) CESIUM BEAM FREQUENCY STANDARDS

Andrew Dickens
United States Naval Observatory
and
University of Virginia

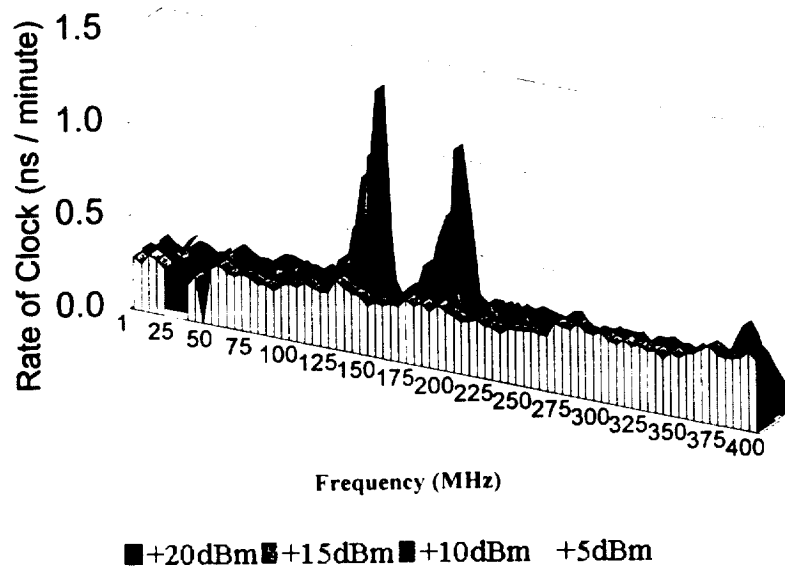
Figure 1 : Clock Rate vs. Frequency and Power

It was found that the clock exhibited sharply accelerated rates around two particular frequencies (Figure 1). The first was at 128 MHz, and the second was around 150MHz.

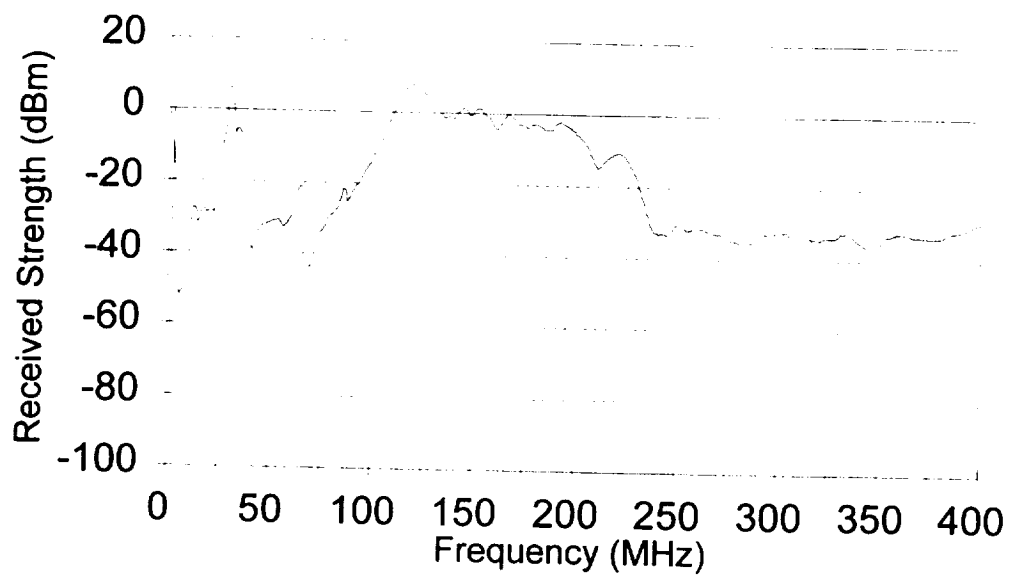
Figure 5 : Antenna Frequency Response

In order to know the real RF strength that was incident upon the clock for any frequency, the frequency response of the antenna needed to be calculated. A matched straight antenna was fabricated and was placed two feet away, parallel to the transmitting antenna. The receiving antenna was connected to an HP 8562 spectrum analyzer. The magnitude of the signal at this antenna was recorded as the signal generator was swept across the frequency band of interest. The matched nature of these antennas allows correction to be made for the characteristics of the antenna. The frequency response plot is shown in Figure 5.
